ANNUAL REPORT

1 August 2016 – 31 July 2017

ST JOHN'S CO-CATHEDRAL

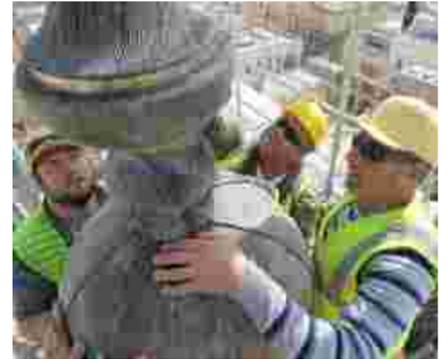
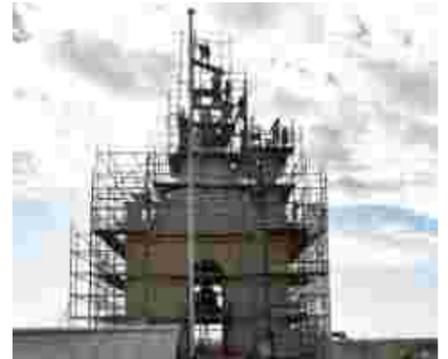
1.3 Restoration of Main Façade and Bell Towers

One of the major projects at St John's Co-Cathedral has been the restoration of the main façade and the belfries. The restoration work started in 2014 and was completed in December 2017. The architectural firm *TBA periti* had conducted a condition assessment survey of the exterior architectural fabric to establish a conservation strategy and programme that included graphical documentation of the masonry. A detailed photographic record of the areas, in their current state, along with mapping of the areas of deterioration, was also conducted. Areas that had been rendered or plastered were also identified to create an illustrated description of the areas that required intervention. The report also included a description of the types of deterioration on the basis of detailed visual examinations carried out on site, including an appraisal of all elements to be restored or replaced.

Each block of stone was checked for any damages, cleaned and repaired. Retaining the original stone was a key element for all interventions required, although slabs that were in an advanced stage of deterioration were replaced. Part of this restoration process was the removal of encrustation and staining caused by atmospheric changes throughout the years and change of seasons. Another intervention was to divert rainwater inwards instead of having it streaming down the middle part of the main façade. To prevent pigeons and other birds from nesting and fouling the sculptural parts, new transparent spikes were installed. Transparent nets were also affixed in front of small windows and other small openings.

Restoration work was also carried out on the wooden apertures of the towers and the wooden beams of the bells in the belfry. These were carefully restored to their original state and repainted.

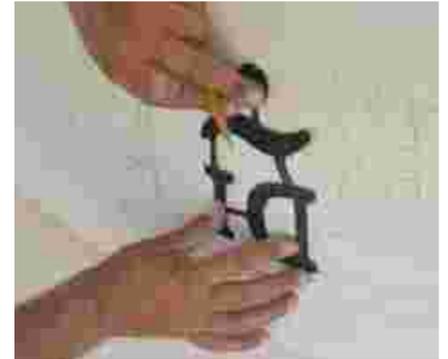
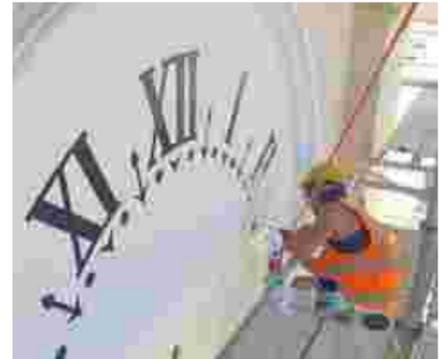
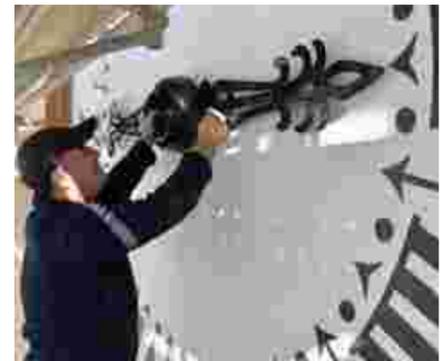
1.4 Restoration of the Clock

The St John's Co-Cathedral Clock is found on the south bell tower of the building. It has three faces marking the hours, the days of the week and the date of the month respectively. The main one is the clock of the hour, beneath which a Latin inscription bears the name of its clock maker, *Clerici invenit*. Clerici, a Maltese clock-maker, connected the clock mechanisms on three bells, one large and two smaller. The three bells have a high relief coat-of-arms of the Grand Master Wignacourt and the large bell has the date 1619, probably the date when it was cast and possibly that of the construction of the clock.

The restoration of the clock consisted of stabilising the deteriorated surface, repair and plaster of the loose parts and integration of the inscriptions, the numbers and the decorative elements.

The surfaces were cleaned of dirty deposits and past restoration materials. Damaged mortar joints were removed and specific plasters were applied to level the surface. The decoration scheme was preserved and the remaining inscriptions, numbers and other marks carefully integrated. All the deteriorated metal supports were replaced with new ones made in stainless steel, whilst the arms were restored separately.

The three metal arms were cleaned of rust, galvanised, and painted with black varnish. The weather vane also required extensive restoration and repair since, with the effects of the elements, the metal had expanded as the vane was no longer functioning. This part was carefully lowered to ground level and was repaired in the laboratory. The wooden spool on which it spun also showed extensive deterioration and had to be replaced. All the moving parts were repaired, and the weather vane was reinstalled.

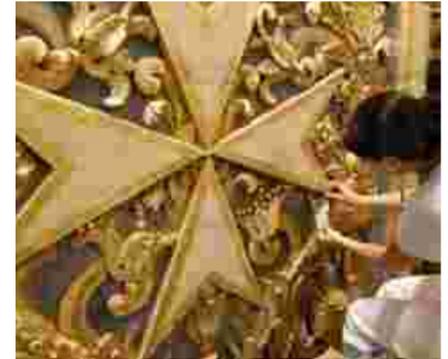
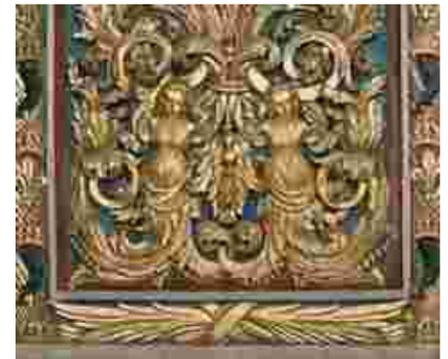
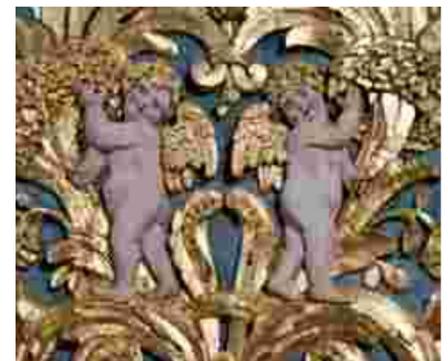
2.1 Restoration of the Gilded Wall Carvings

The areas treated during this year were the painted and gilded surfaces on the inner pilasters of the chapels of Philermos, Auvergne and Provence. The conservation problems were mainly caused by the rising damp and salts, and the resulting detachment and de-cohesion of the gold and the colours from the stone. The deposits of dust and particularly air pollution that had accumulated over the years have caused the gold to appear dull and grey, and the solubilisation of the binder used for the application of the gold leaf and the consequential loss of the brilliance of the gold. The damaged areas were consolidated with the most suitable materials. The abrasions and the lacunae of the coloured surfaces were retouched with watercolours, while the losses in the gilding were reintegrated using the same gold leaf as the original technique. All the surfaces were dusted and cleaned to remove the different kinds of deposits.

The surfaces where the gold had completely lost its brilliance were cleaned and stabilised. In accordance with the aesthetic quality of the interiors of the Co-Cathedral, all the abrasions and the areas where the gold leaf appeared poor and dull were reintegrated with the same quality of gold leaf and gilding technique as had been used originally. The type of binder using an oil-based medium proved to be the most suitable for the inner microclimate of the church and was found to be the best solution to ensure the longevity of the gilding. Maintenance treatments are planned to be carried out frequently to avoid the accumulation of dust during the year, as well as monitoring of the rising salts on the surfaces to preserve the integrity of the decorations.

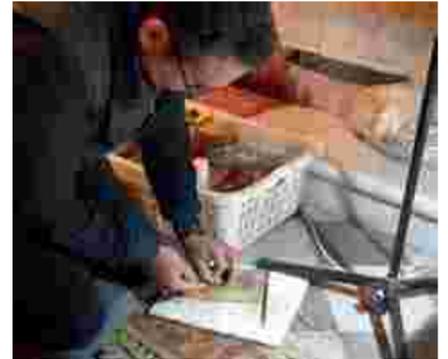
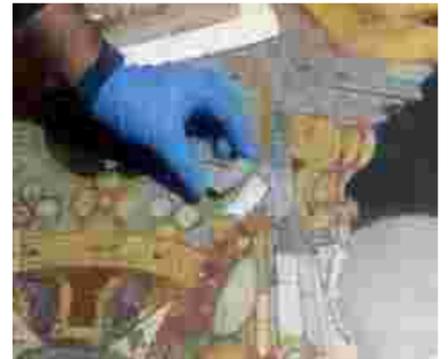
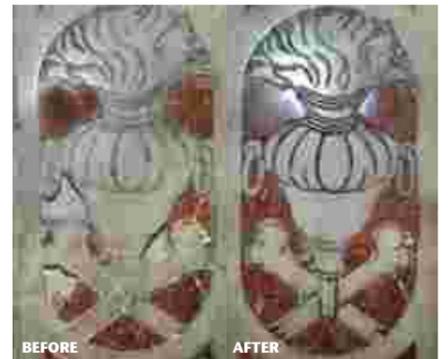
2.2 Restoration of the Inlaid Marble Floor

Though marble is considered to be a durable material, it suffers from damage caused by abrasion. The inlaid designs and motifs made of thin marble on the tombstones are also susceptible to cracking, with the passage of time as well as weight, leading to losses in the inlaid marble layer. The restoration of the inlaid marble tombstones is executed according to a priority conservation management plan.

The Foundation employs two full-time marble restorers to repair and preserve the tombstones, as well as the marble monuments. The laborious work involves the skilful consolidation of any loose parts, and the replacement of missing pieces. The restoration of the tombstones is an arduous task and is the main occupation of the in-house marble restorer Jesmond Bartolo. The restoration and conservation of this precious floor consists of replacing the missing inlaid parts with matching marble, often very difficult to obtain, using the appropriate techniques. All restoration is recorded and documented.

During this year, restoration was carried out on forty-two tombstones, including, for example, those commemorating Pompeo Rospigliosi in the chapel of Philermos, Rene de Maisonseule in the chapel of Auvergne, and Bernardo Scaglia, the oldest tombstone present in the Church. The aim was to restore large or small losses that had occurred with the passage of time. Materials used during past restoration interventions not compatible with the marble were removed. All the tombstones in the main nave were examined and each tombstone that had sustained losses was cleaned up, and replacement was carried out with new marble parts of the same type and colour. In addition, all the losses of the profiles and inscriptions caused by the abrasion of footfall on the surface were filled using suitable materials to render the incisions visible and enhance the aesthetic quality of the design.

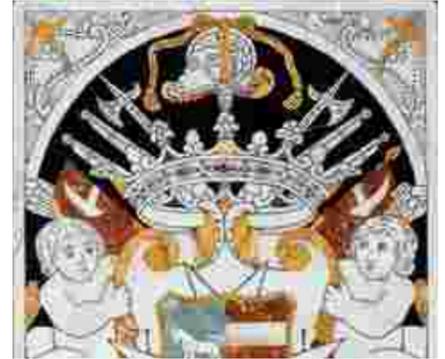
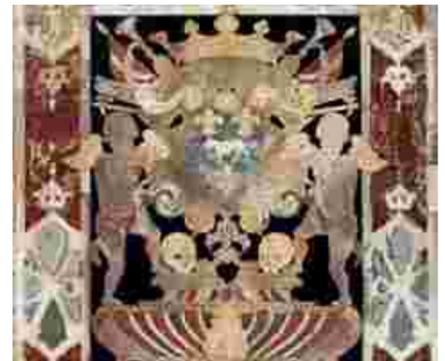
2.3 Graphic Documentation of the State of Conservation of the Tombstones

The mapping project commenced in 2015 with the aim of recording the state of conservation of all the tombstones in the main nave, the chapels and the oratory. The study consisted of recording the type of existing damage and its progress. The analysis of the study will assist in identifying the deterioration connection between the manufacture technique of the tombstones, that is the type of marble, thickness, position, the subsoil condition, such as lifting and the presence of rising damp, and the accidental causes of deterioration by breakage and footfall abrasion.

Visual analysis was followed by a digital survey of each tombstone using the latest technology and software. The mapping of the various types of damage and deterioration was carried out with the use of specifically coloured symbols on black and white images of the tombstone. Each symbol refers to the specific type of damage present in the legend.

Each mapped tombstone was recorded on a data sheet, with the record being identified by name and number of the tombstone, and accompanied by historical information about date and placement, as well as technical information about dimension, type of marble, name of the artisan and date of past restorations documented. The graphic documentation collected and concluded in 2016 will be used as a database for marble cataloguing. It will also serve as a database for maintaining a restoration programme that will be updated periodically.

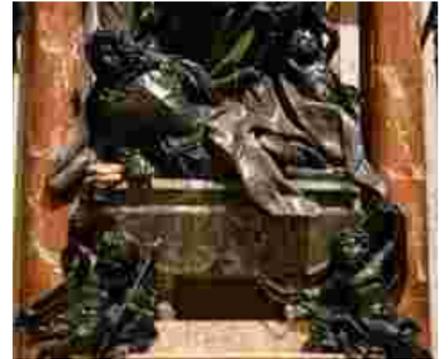
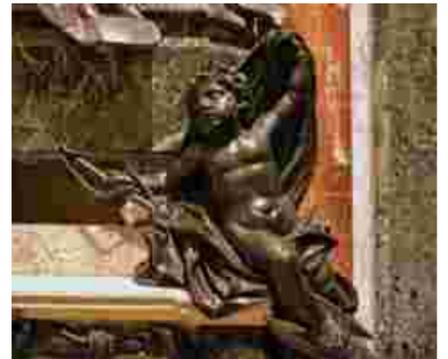
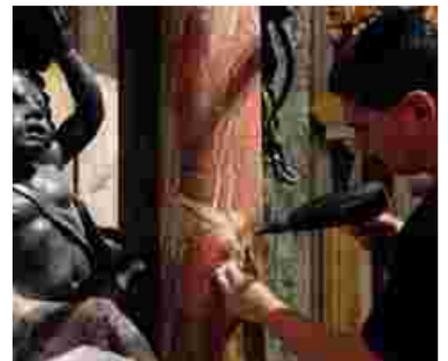
2.4 Conservation of the Funerary Monument of the Grand Master Marco Antonio Zondadari

The Grand Master is represented in a full-size bronze figure wearing armor and laid on a sarcophagus of green marble, with his left arm over a pillow of yellow marble. The urn rests on a high marble pedestal is held by two bronze figures of Faith and Hope. Behind the Grand Master are displayed two enormous marble banners and a set of lances realized in bronze. Between these the figure of Charity and a small *putto* emerge to hold up one of the standards. On the dado is the commemorative inscription on a black marble slab, above which is an elaborate bronze scroll with an ornamental termination of wolves' heads. The composition is framed by two red marble columns, set on diagonally displaced pedestals and rising to sustain the entablature. Above the white marble cornice there is a large central coat-of-arms between other trophies and putti made in bronze.

The monument was examined and found to be in a structurally good condition. The conservation treatments focused on reviving the aesthetic qualities of the monument, removing the thick layers of dust and grime. Tests were carried out to identify the most appropriate cleaning methods to remove the aged wax applied to the marble elements during previous interventions and other deposits, whilst the bronze parts were simply dusted.

Subsequently, the marble surfaces were treated with new wax and polished to revive the natural brilliance of the marble. These operations were carried out by the Foundation's resident marble restorer, Raymond Aquilina, under the supervision of the in-house conservator Adriana Alescio.

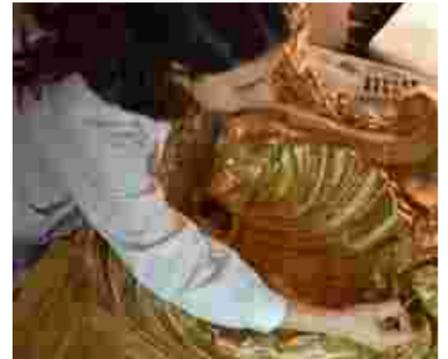
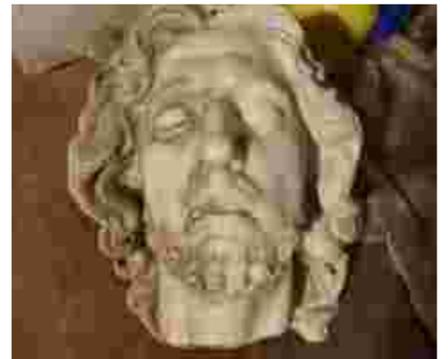
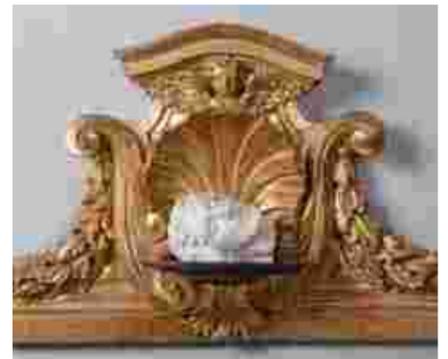
2.5 Restoration of the Head of St John the Baptist and the gilded wooden mural plaque

The marble sculpture was found to be in a good condition despite the huge amount of dust and dirt that covered the surface. The old coating had also become dark due to the high retention of dust accumulated especially between the waves of the hairs and the beard.

The wooden plaque was in a bad state of conservation due to cracks, missing parts and abrasion spread over the surface. The plate, where the head was inserted, was completely abraded and the original gilded decoration was totally missing as in the external part. Lacunae were present along the foliage and fractures were noted in the central part of the shell; gold losses and abrasion were evident on the base where many etches representing inscriptions, names of saints and sketches of ships were found.

The marble sculpture was inspected, separated from the plaque and transferred to the temporary lab of the Co-Cathedral. It was dusted using soft brushes and a vacuum cleaner to remove the large amount of dust. Specific tests were carried out to identify the most appropriate cleaning methods to remove the aged wax applied during previous interventions and other deposits without dissolving the original patina. Finally, the marble was treated with a new layer of wax to protect the surface and to obtain the desired finish.

The wooden plaque was treated separately. All the deposits of wax, such as candle-wax drips, were removed mechanically from the surface; cracks, fractures and missing parts were repaired and filled with *gesso di Bologna* mixed with animal glue. Metal inserts were cleaned of rust and stabilised. All the lacunae and the abrasions were integrated by using watercolours and varnish colours to match the gold leaf tonality.

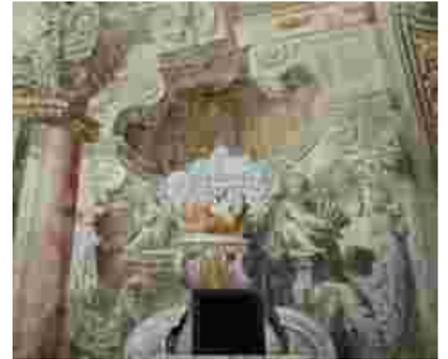
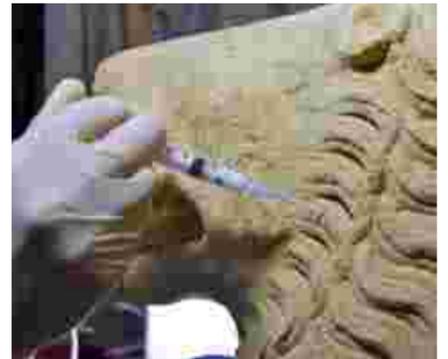
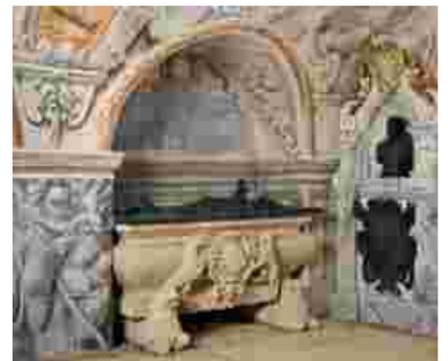
2.7 Maintenance of the Grand Masters' Crypt

The scope of the maintenance within the Grand Masters' Crypt consisted of a series of treatments to stabilise the condition of those areas where deterioration had reappeared after the last restoration. This was due to the porous character of Maltese limestone and the crystallisation and deliquescence cycle of salts.

Studies of the deterioration showed that the same areas were affected before the restoration of the entire crypt was carried out. This was especially the case in all the pilasters below the frame, the west side of the altar, and the monuments of the Grand Masters L'Isle Adam, and de Valette. Observation was also carried out on all the painted surfaces and the state of conservation of the other monuments, to be sure that the deterioration had not extended to the most stable areas.

The main treatments were the consolidation of the monument of L'Isle Adam, and re-filling of the fractures found on the pilaster close to the entrance. The painted surfaces were dusted, and localised re-efflorescence was removed by using soft brushes or sponges dampened with deionised water. The bases of tombs and walls were checked and cleaned with a vacuum cleaner, as was the flooring. The consolidation of the monument of L'Isle Adam was carried out by injecting nano lime dispersion used in different concentrations of up to 50g/litre, applying the same methodology recommended by the Courtauld Institute of London, which had carried out the restoration of the Crypt in 2012.

Nano technologies were introduced in the restoration field in order to find *avant-garde* consolidation solutions for artefacts where other organic or in-organic materials were not completely effective, as with those subjected to moisture. The formation of calcium hydroxide nanoparticles and their dispersion in aliphatic alcohols has generated a product able to be used in such extreme conditions, ensuring greater kinetic stability thanks to the nano-sized particles, greater penetration

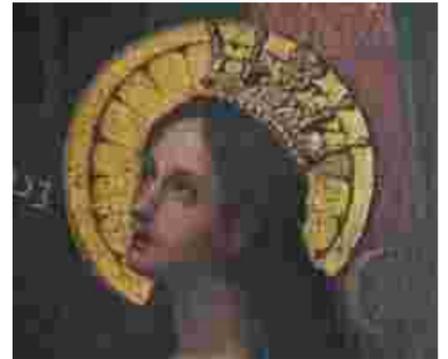
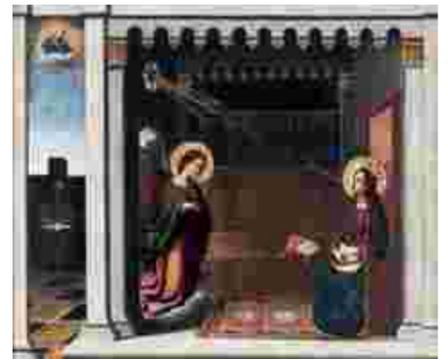
The oil on canvas painting representing the Annunciation is a copy of a 15th century painting of the same subject. It was commissioned by Pietro Urrea Camarasa, Prior of the church, whose representative escutcheon is shown on the left side of the painting. According to documentation about the painting it seems that it was first placed in the sacristy, and then moved into the chapel of the Blessed Sacrament. The strainer and the decorative frame were replaced during a past restoration as were the relining and two panels on the back, probably inserted to isolate the painting from the wall and protect the canvas from the humidity. Despite the good state of conservation of the canvas and the strainer too, the surface appeared to be yellowed due to the aging of the protective varnish, whilst some areas appeared dull and dried up. Craquelures were lightly diffused over the all surface.

The aim of the restoration was to revive the aesthetic quality of the painting, by cleaning the varnish layer and removing the deposits of dust and dirt. Overpainting was removed, paying specific attention to unstable and faded colours. *Lacunae* revealed after cleaning were retouched using transparent varnish colours and given two applications of varnish in order to saturate the colours and protect the surface.

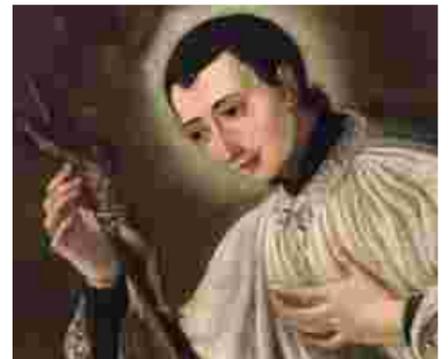
The painting was found to be in a poor state of conservation due to the unstable condition of the canvas and the presence of holes easily visible from the surface.

The wrong straining of the support and the stiffening of the canvas had caused tears around the nails along the perimeter and the consequential deformation of the canvas. The paint layer was tarnished due to the aging of the varnish and craquelures were mostly concentrated on the left side of the Saint, probably due to the excessive use of heat during a past intervention.

The aim of the restoration was to remove the deformation of the canvas and clean the surface of the dust and dirt deposits. Cleaning tests were carried out in order to find the best methodology to remove the overpainting. The canvas was consolidated from the rear side; the edges were reinforced, and the holes mended with patches of synthetic canvas. All the lacunae revealed after cleaning were filled and retouched with watercolours and varnish colours. Finally, the surface was coated with two layers of protective varnish.

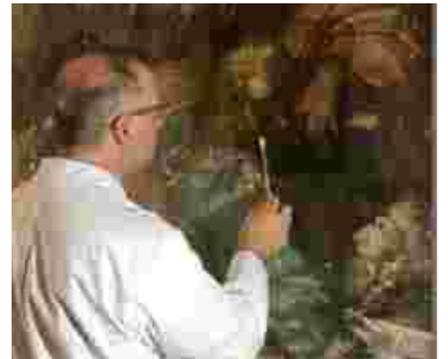
The painting dedicated to the Assumption and *The Coronation of the Virgin Mary* is one of the largest paintings belonging to the church, measuring 3.80 x 3.10 cm. It once hung on the south wall of the sacristy, above the entrance, but at a later stage it has been stored in the Picture Gallery. This oil on canvas painting is datable to the late sixteenth century and is by an unknown artist.

The reconstruction of its historical vicissitudes, provenience and manufacture techniques, will be able to assist in restoring it to its former condition.

The conservation-restoration project is being carried out by Sig. Charles Vella under the direction of the Foundation's curator Cynthia de Giorgio and the supervision of the conservator Adriana Alescio.
